PROPOSED REPAIRS

**PAINTED ROCKS  
DAM**

DRAFT ENVIRONMENTAL  
IMPACT STATEMENT

AUGUST 1976

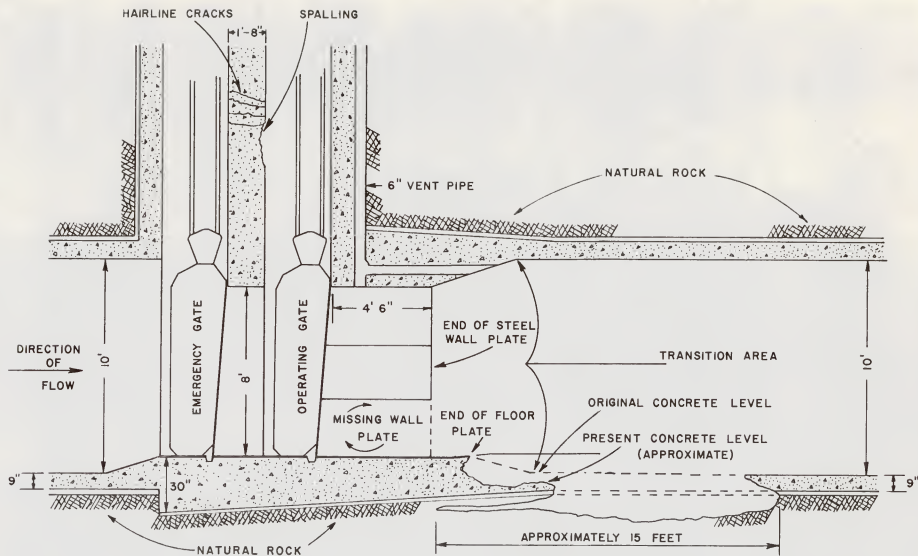
Figure 4. CROSS SECTION OF GATES AND TRANSITION AREA SHOWING DAMAGE

During the high flows in the spring of 1975, Painted Rocks outlet tunnel sustained significant damage. In the transition area of the outlet tunnel, concrete, reinforcing bars, and a section (two feet by five feet by one-half inch thick) of steel plate were washed out, leaving in one location, only natural rock as the water-carrying surface (Figure 4). The concrete wall separating the operating and emergency gate towers was also damaged; cracked and deteriorating, the wall leaks when the operating gate is not in use and the emergency gate is used for regulation or stoppage of flows. This leakage results in the ineffective use of the emergency gate.

The concrete wall which separates the emergency and operating gate towers is deteriorating (see Figure 4). Parts of this wall are cracked and *spalling*, so that, when water fills the emergency gate tower, it leaks through to the operating gate tower. If these cracks enlarge, repairs will be necessary or the potential use of the emergency gate will be lost. Repairing these cracks would call for the draining of the reservoir to eliminate water pressure upon the wall between the towers.

The worst deterioration is in the transition area of the outlet tunnel of the dam, the location of repairs in 1954 and 1974. Deterioration in the transition area is a result of cavitation, a process that occurs when water encounters a decrease in pressure while moving rapidly from the confined area at the gates into the enlarged area of the transition zone. This decrease in pressure causes vapor bubbles to be formed. These bubbles are carried along with the water until a region of higher pressure is reached, where they suddenly collapse. The ensuing inrush of water produces regions of high pressure which extend into the pores of the adjacent metal or concrete and tear material from the solid surfaces resulting in pitting. Concrete on the tunnel floor and sidewalls has eroded substantially from this process and, in one location, is down to bedrock. A section of the steel plates has washed out from the sidewall of the transition area, and concrete erosion is taking place behind other plates.

On September 29, 1975, representatives from the Bureau of Reclamation joined with DNRC to make another inspection of the severely damaged outlet tunnel. Further investigation revealed undermined areas beneath the remaining concrete floor (Figure 4). By probing with a tape measure, many areas were found to have voids in excess of two feet. A maximum undermined distance of six feet was measured.

To restore the safe operation of the dam and prevent dam failure, it is proposed that the damages be repaired. Repairing the outlet tunnel will make the dam fully functional again; presently, the use of the tunnel is being limited to prevent further damage. However, the tunnel must be used to empty the reservoir for repairs. Repairing the wall between the gates will restore complete emergency control of the dam in the event that the operating gate becomes non-functional. Repairs to the intermediate wall will require the draining of the reservoir to allow dry access to the upstream face where the cracking originates (Figure 4).
